NEWSLETTER OF CLUND & SON LTD • DECEMBER 2011

EMERGENCY RESPONSE

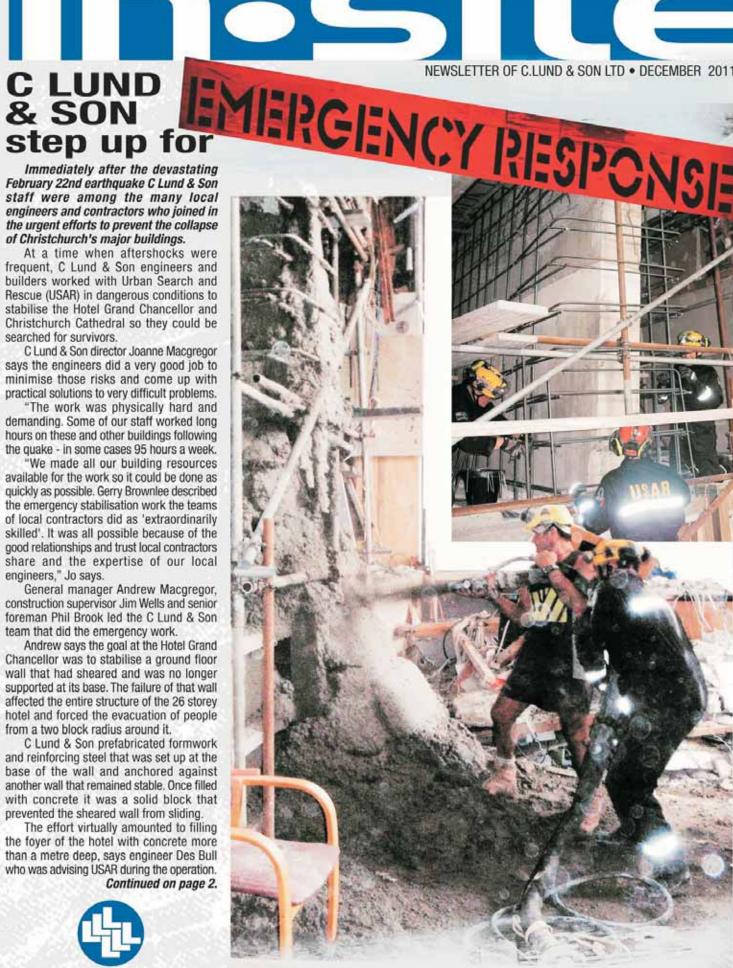
Top: USAR staff weld reinforcing steel fabricated by C Lund & Son to strengthen a damaged column in the Grand Chancellor Hotel with concrete. Bottom: Spraying the concrete to strengthen the column.

"When the ground floor wall collapsed it damaged a major structural support beam and columns on upper levels of the hotel. To reinforce them we gained access through the 12th floor via the undamaged parking building next to the hotel. We built steel casings to fit around the damaged columns. They were bolted together and filled with concrete," Andrew says.

The C Lund & Son team used similar steel and concrete jackets to stabilise damaged columns in the BDO Spicers Building and Copthorne Hotel Christchurch.

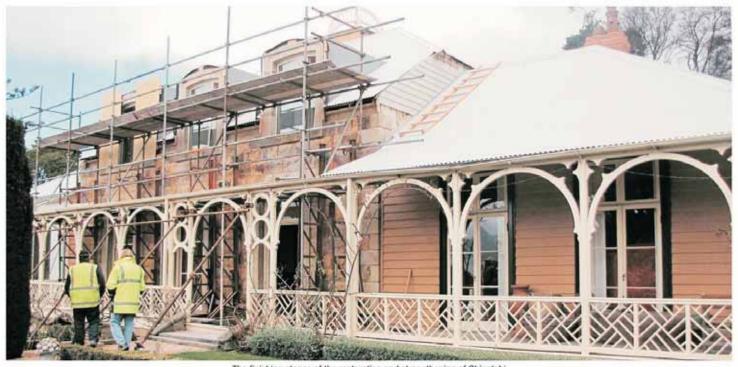
The finishing stages of the restoration and strengthening of Ohinetahi.

The first step was to use a crane to remove the stone that had collapsed onto the bottom storey. It was not a small job. The walls of the upper stories were 450mm thick and eventually 160 tonnes of stone were removed from the damaged building. It was salvaged and has since been used to build an amphitheatre in Ohinetahi's garden.

"Once the stone was removed we were left with a 12m x 12m square of stone walls on the ground level. The Lunds team, led by Jim Wells put in a 150mm thick concrete layer on the inside of the stone walls.

"They drilled into the stone and connected the concrete skin to the stone with diagonal rods. Concrete beams were laid at the top to tie the walls together.

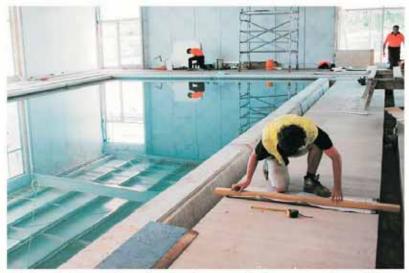
Complex plumbing, careful concrete work, and vapour proof barriers are some of the specifications C Lund & Son builders had to meet when building the new pool at Pioneer Stadium.

The ability to raise and lower the water level makes the pool's plumbing and drainage systems complex.

"The pool has a separate tank. Water can be added to the pool or drained away to change its level. To connect the pool to the tank, a lot of pipework with accurate flows had to be laid beneath the pool before the concrete was poured. Our subcontractors PBS did a very good

To build the tank, the Lunds crew put down sheet piling and pumped out the ground water. They then poured the concrete tank in situ.

For the pool itself, the excavated cavity was first lined with a plastic waterstop lining that had to be welded together before the reinforcing steel was put in place the and concrete poured.

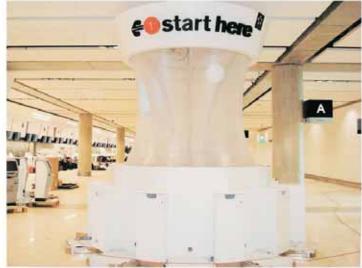
The self check-in counters Lunds Joinery built for Air NZ have a High-Macs base and middle section of Kaynemaile.
